Introduction

Acceptable Appearance

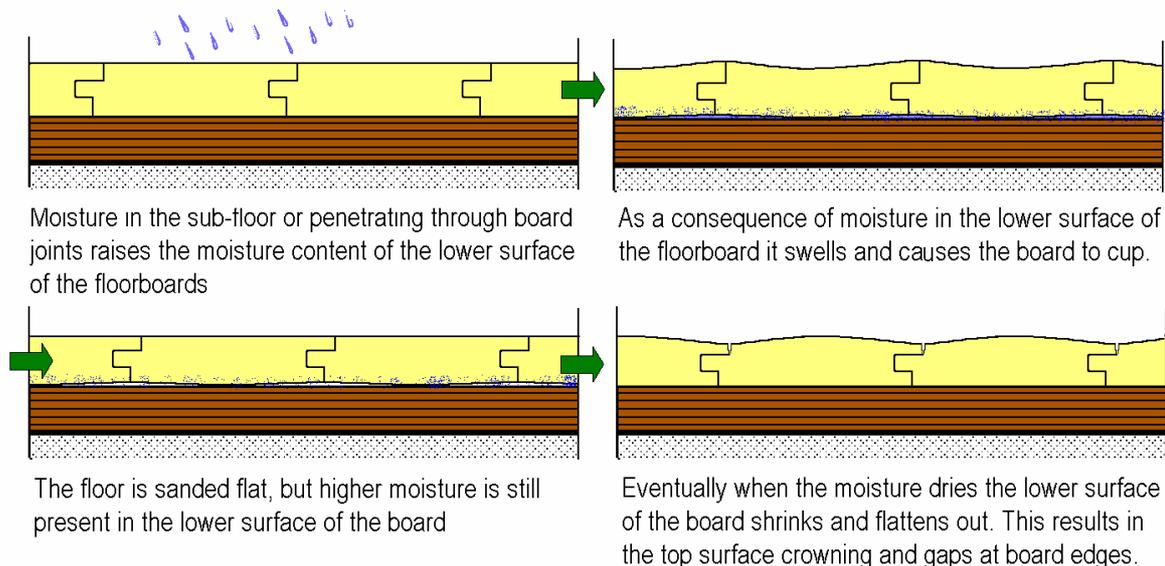
Figure 1 - The process of crowning

- occur in some locations within a dwelling (e.g. sun exposed floor) where these types of flooring are used.
- Tenting - two adjacent boards, where the adjoining edge has lifted above the level of the adjacent flooring. This is often associated with high moisture beneath the floor and can be from many causes.
- Buckling - a section of flooring containing a number of boards raised above an adjacent section of flooring.
- Crowning - floor boards that are flat on their lower surfaces but where the upper surface has its edges lower than the centre of the board. This may occur if a floor is cupped (board edges up) at the time of sanding. Crowning does not become apparent until some months after finishing.
